NARRAGUAGUS RIVER BASIN
CHERRYFIELD, MAINE

CHERRYFIELD DAM
ME-00061

PHASE I INSPECTION REPORT
NATIONAL DAM INSPECTION PROGRAM

MARCH 1979

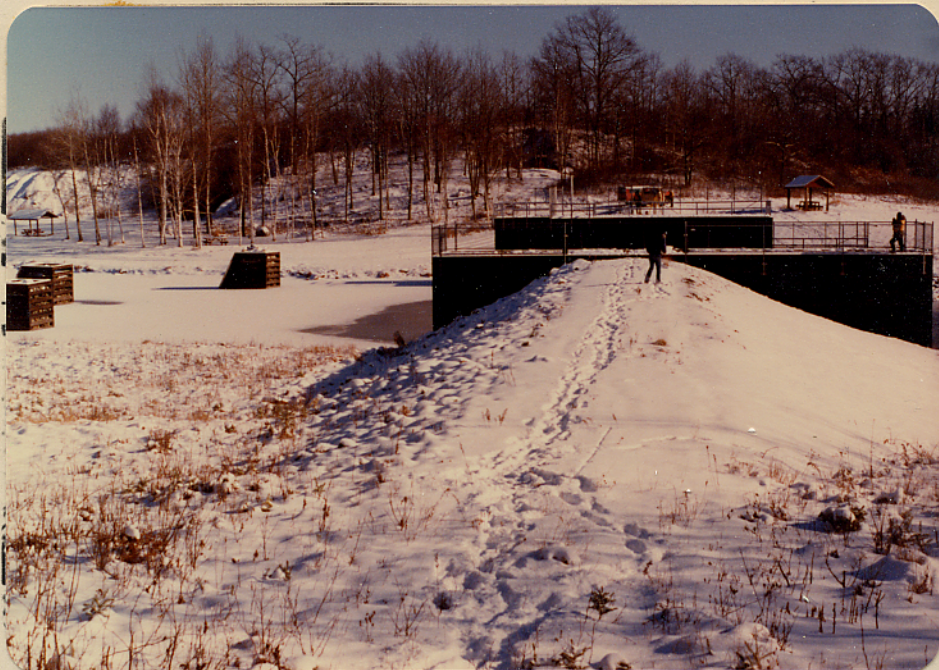
1

VIEW FROM WEST END OF DAM

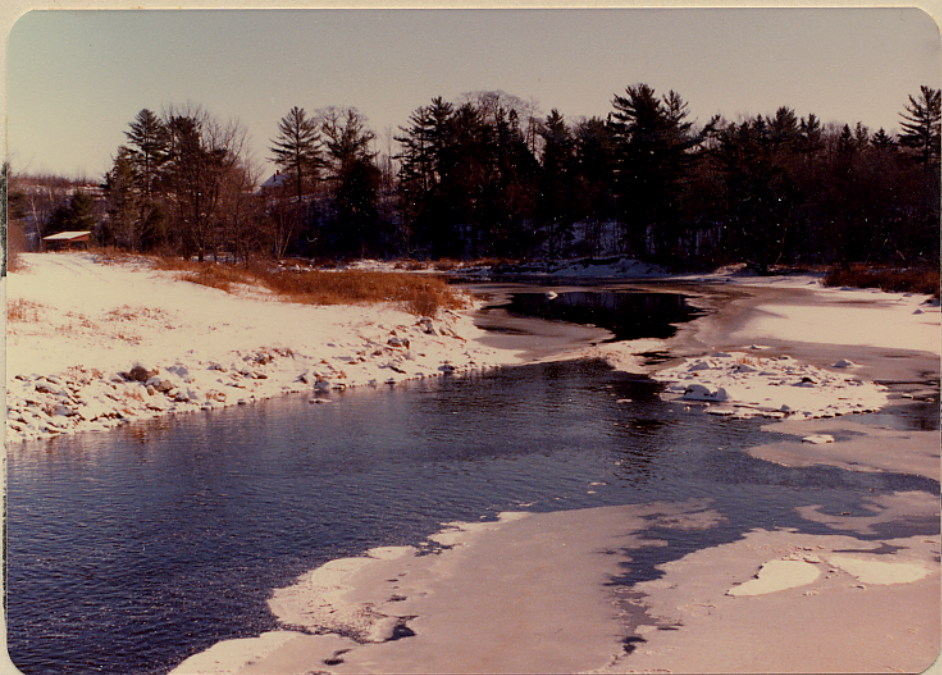
2

DOWNSTREAM CHANNEL

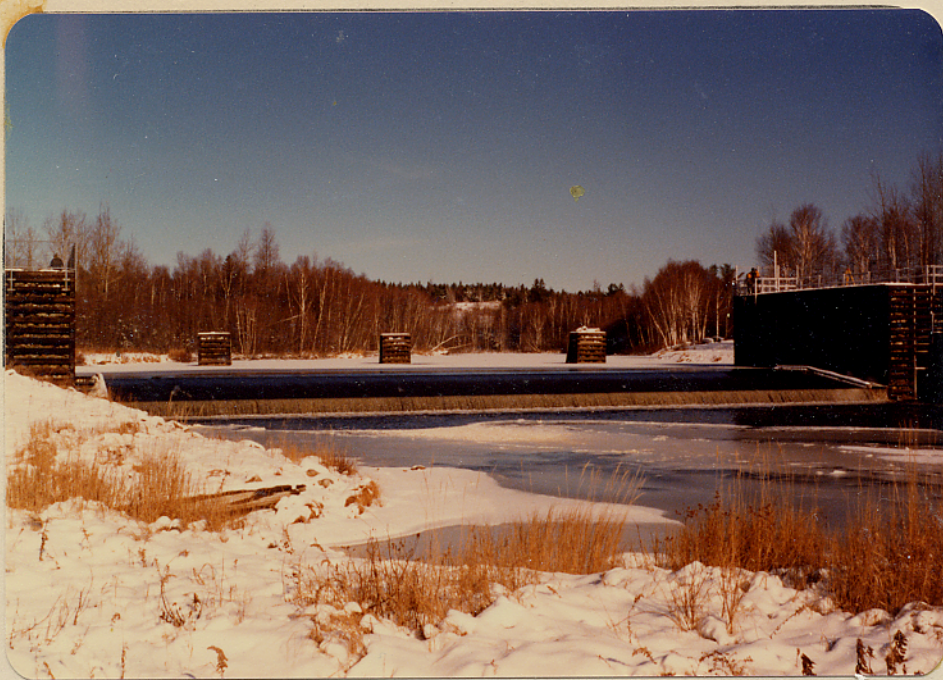
3

DOWNSTREAM FACE

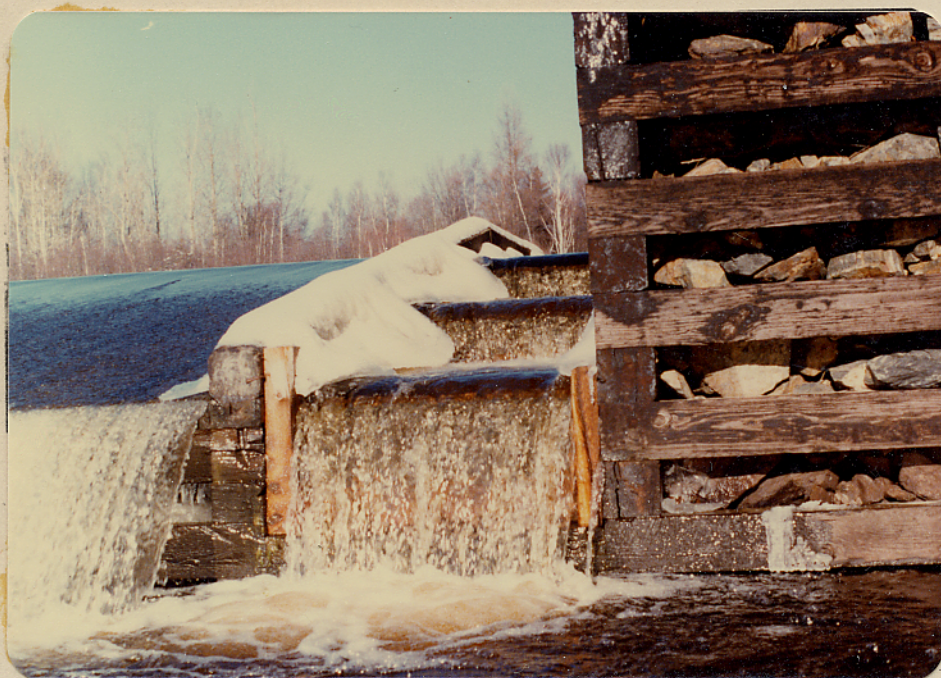
4

DENIL-FISHWAY AT EAST ABUTMENT

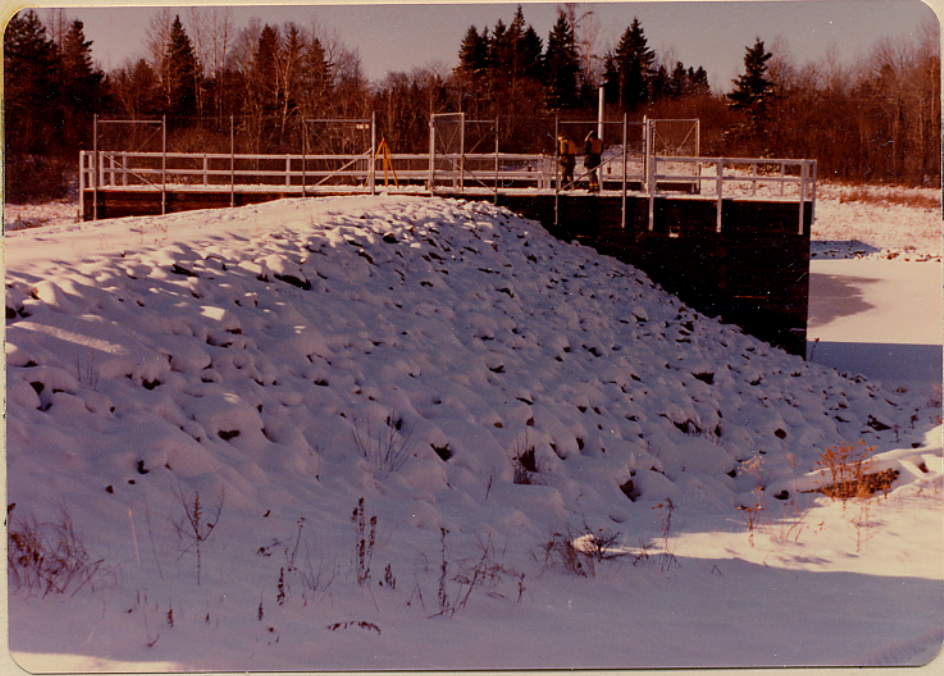
5

VIEW FROM EAST END OF DAM
